Appendix A
Illustrations: Existing Condition
Photographs with Key Plan

Preservation Plan
First Unitarian Society of Plainfield
724 Park Avenue
Plainfield, New Jersey 07060

PHOTO KEY

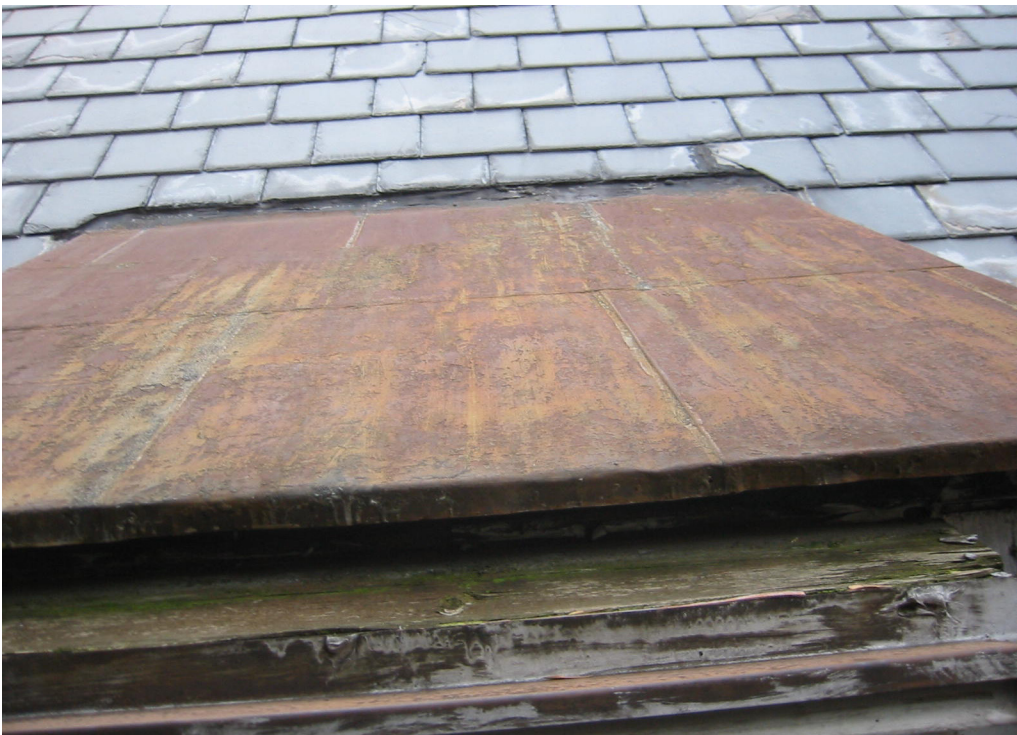
Photograph #32: The metal roof over the shed dormer on the south side of the Parish Hall slate roof. The flat pan tin roof has severe corrosion and deteriorated paint. The wood trim below is rotten in several locations.

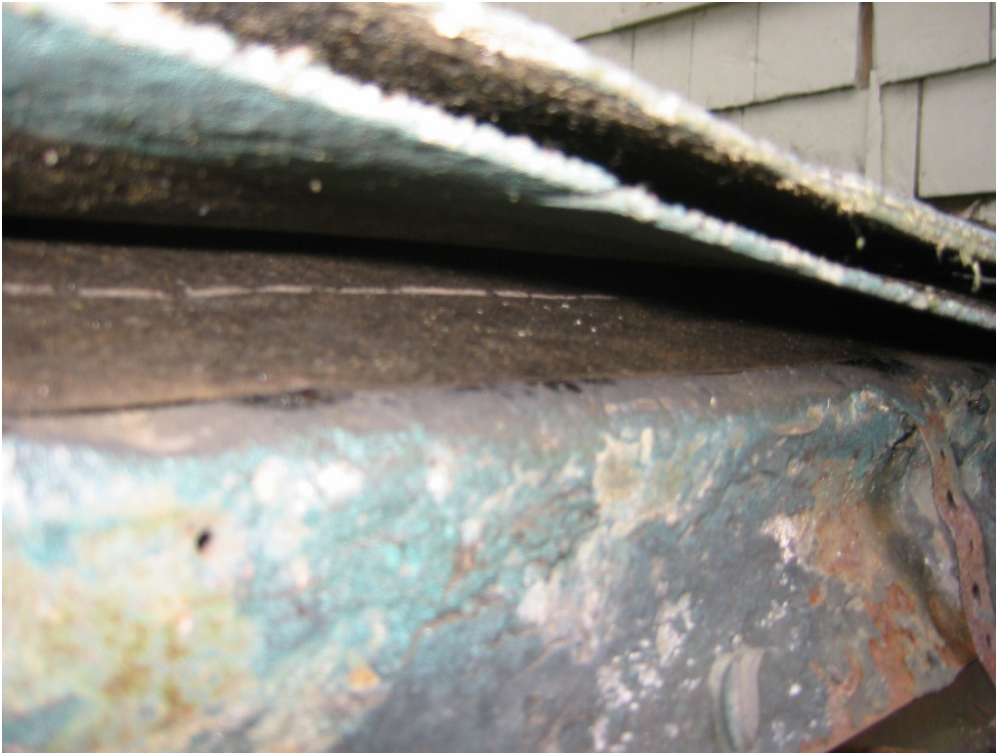
Photograph #33: Close up view of the eaves on the north side of the Church lower shed roof. The original flat pan tin roof is covered with asphalt shingles. None of the flashing appears to have been properly repaired when the asphalt shingle roof was installed.

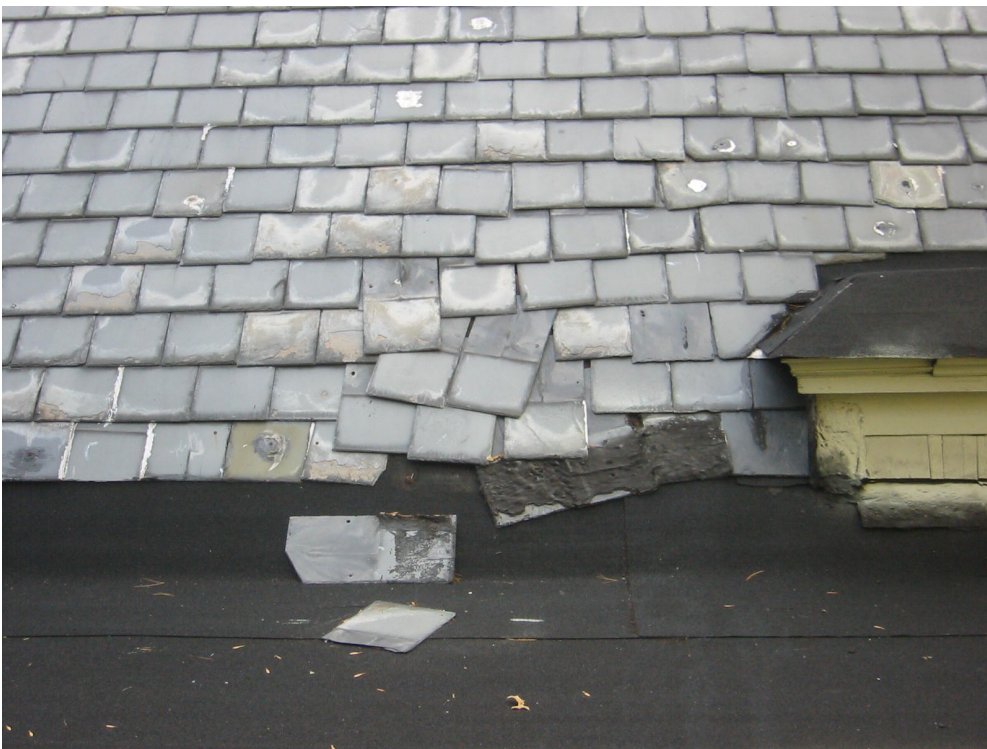
Photograph #34: Slate roof on Parish Hall in poor condition. Large quantities of slate are broken or missing. Many have been covered with tar. The attachments for the slate have corroded and failed. The white staining and rotting of the slate at the edges indicates that the slate has reached its life expectancy (80 years).

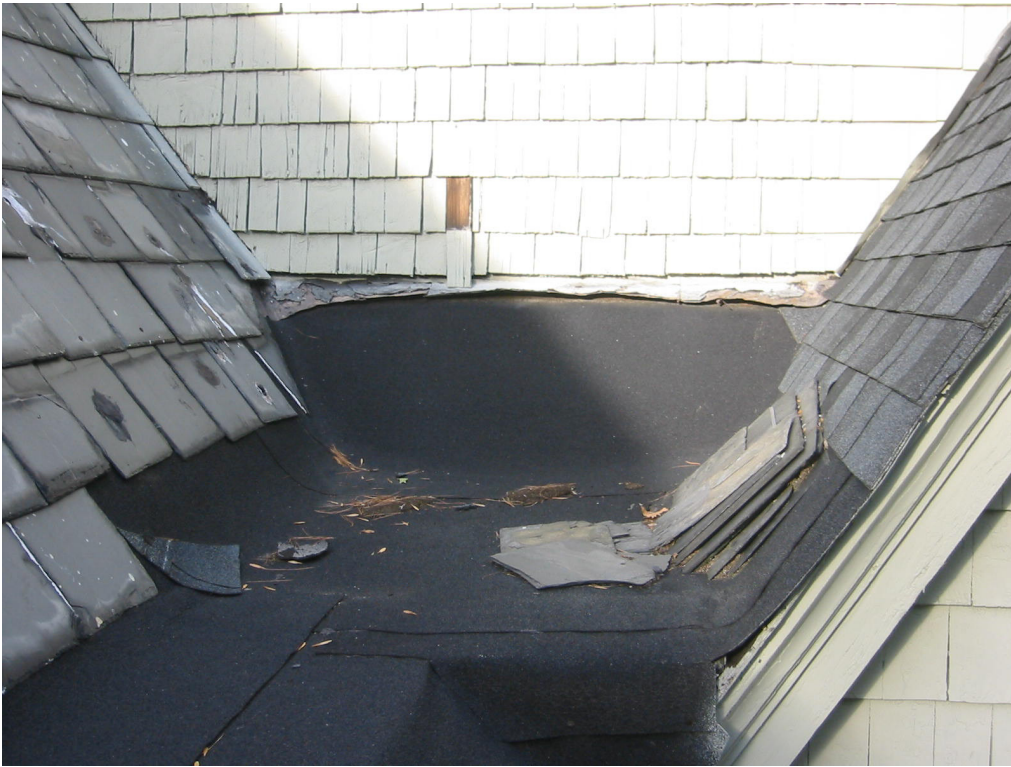
Photograph #35: Junction between the Parish Hall and West Gable Church roof meet on the southwest side of the buildings. The wood shingles on the west wall of the Church are in poor condition with failure of attachments, ultraviolet damage crating deep grooves in the grain and failing paint due to poor preparation and application. The slate roof on the left has failed and, in doing so, perforated the built up roofing materials. This area is vulnerable to ice and snow build up.

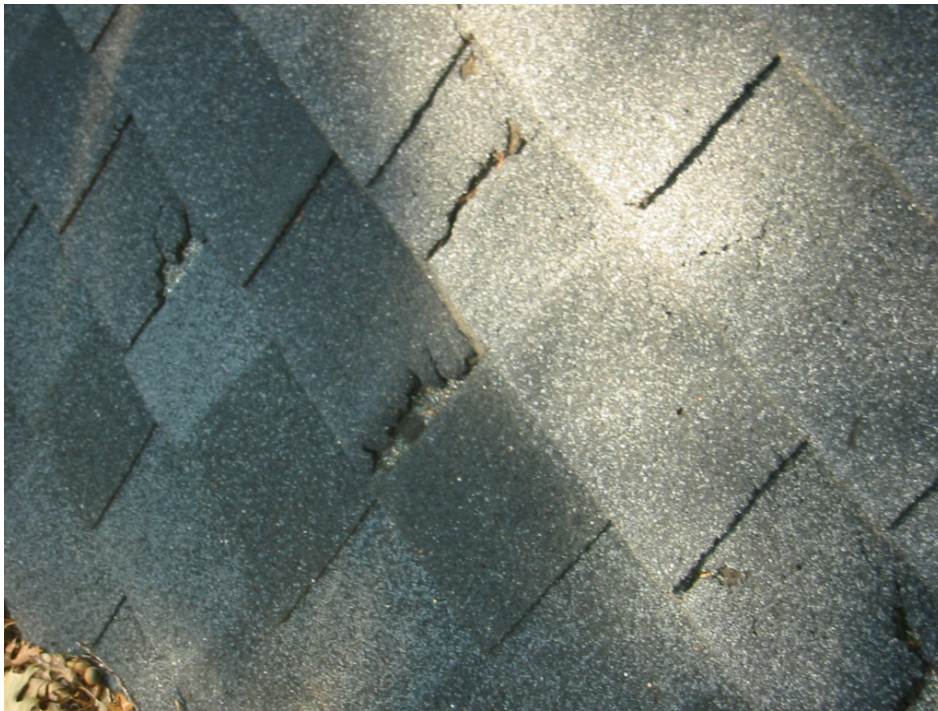
Photograph #36: Detail showing deteriorated asphalt shingles on the north side of the Church roof. The asphalt shingles were installed in 1981 and are heavily weathered and at the end of their life expectancy (20 years).

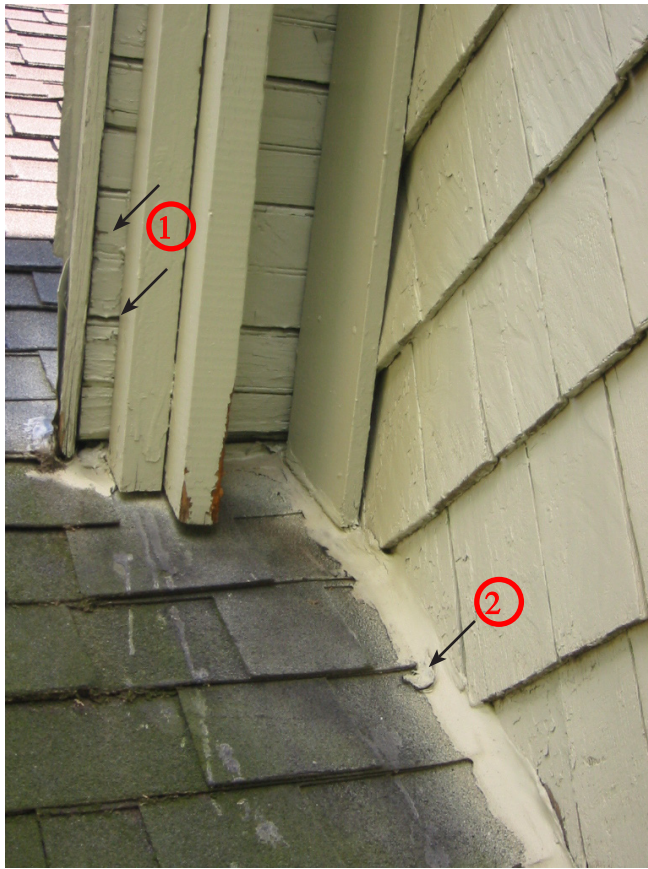
Photograph #37: Detail where the Church adjoins the East Gable wall of the Parish Hall. Beaded board was used for the exposed roof decking but has some rot especially at the exposed gable edge. (#1). The wood rake boards and wood shingles on the Parish Hall appear to be painted and maintained and are in relatively good condition. The caulking, used at the flashing junction between the asphalt shingle roof and the wood shingled wall, is poorly installed, inappropriate and failing (#2).

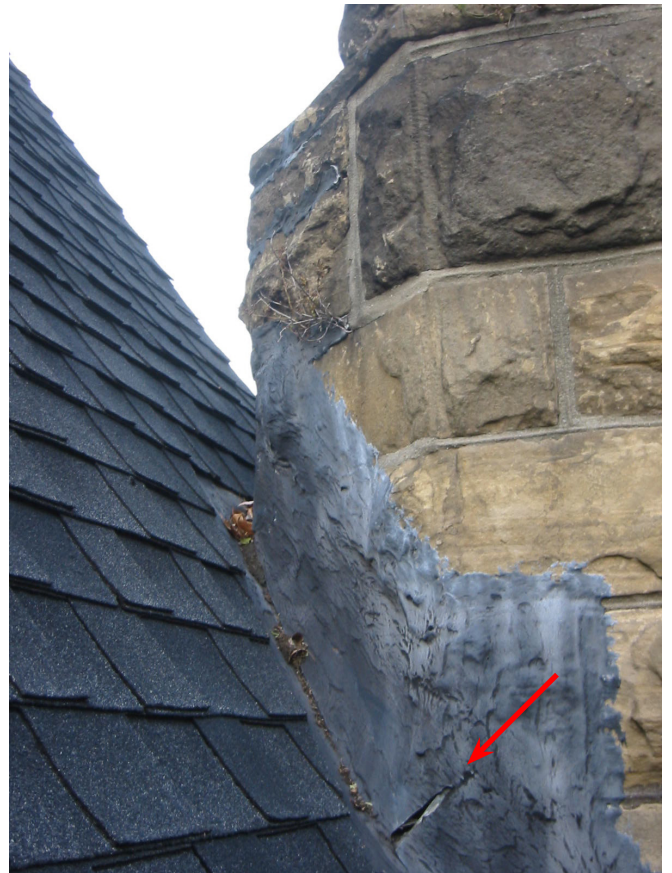
Photograph #38: Detail of the south side of the Church showing the connection of the stone tower with the asphalt shingle roof. Tar has been used as flashing and caulking. This detail is not only unsightly, it is damaging to the tower stone work and is failing which is allowing water to ingress the tower masonry (See arrow). This was an inappropriate repair probably completed as part of the asphalt shingle roof installation in 1981.

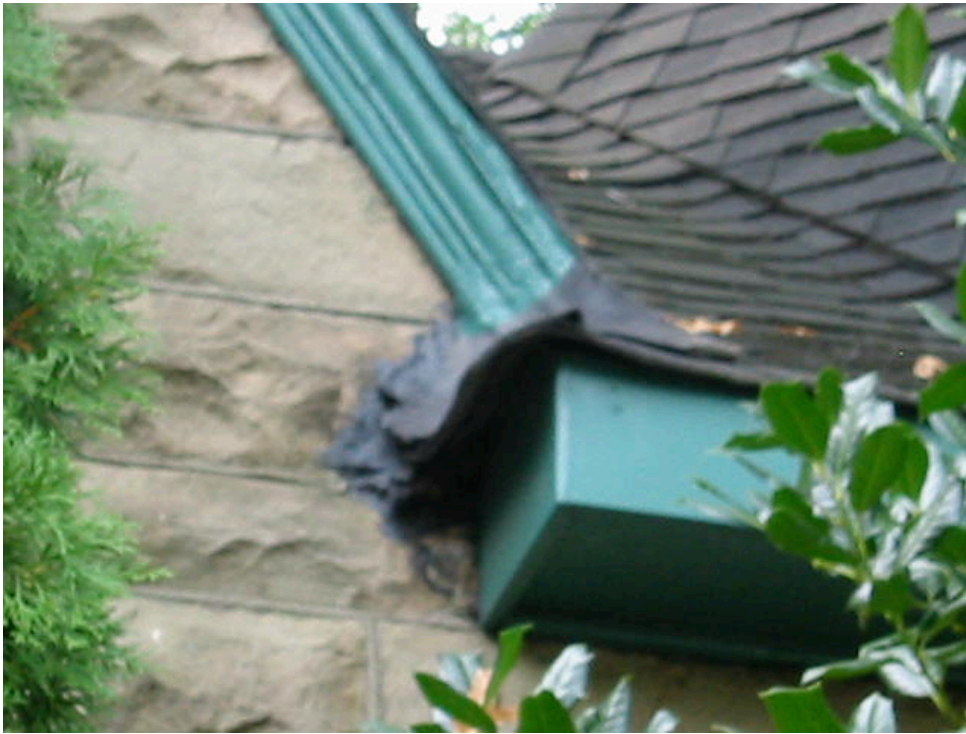
Photograph #39: Tar and flashing have been used inappropriately at the junction of the East Church Gable and octagonal room. The water is being directed from the roof down the Church wall face saturating the stone. The decorative wood cornice has been replaced with a boxed out element not in keeping with the architectural character of the building. The roofing overhanging the boxed cornice has also allowed insect infestation.

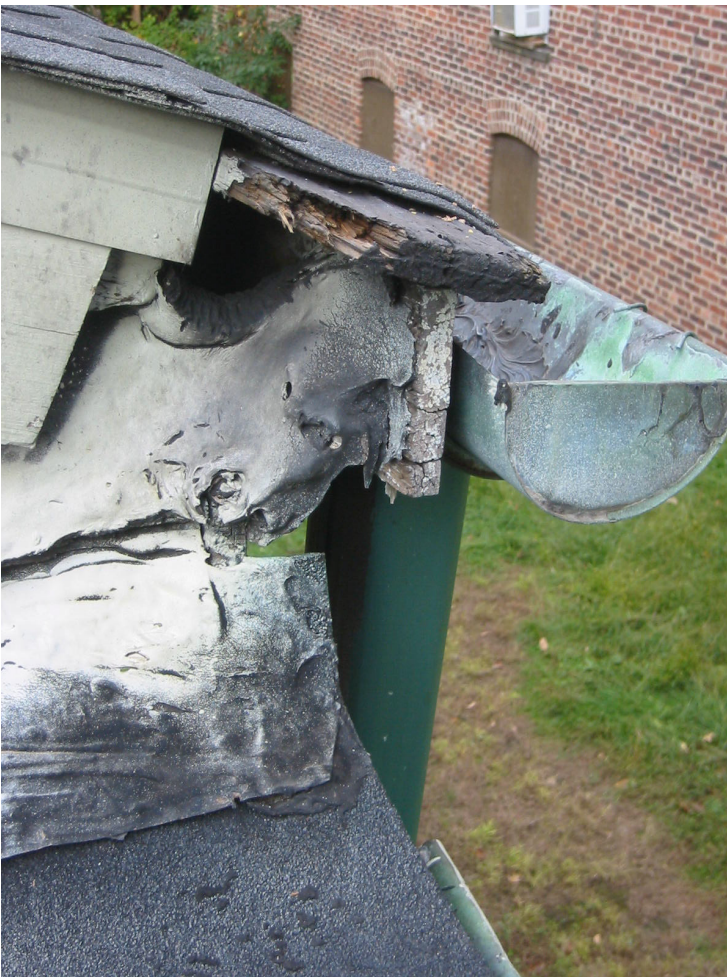
Photograph #40: Detail at West Gable Wall at the Church. The deteriorated condition at the rake board is a result of pest infestation and poor temporary repairs. There is a large amount of rodent infestation in this attic area, which should be prevented as soon as possible to avoid destruction of electrical wiring by rodents.

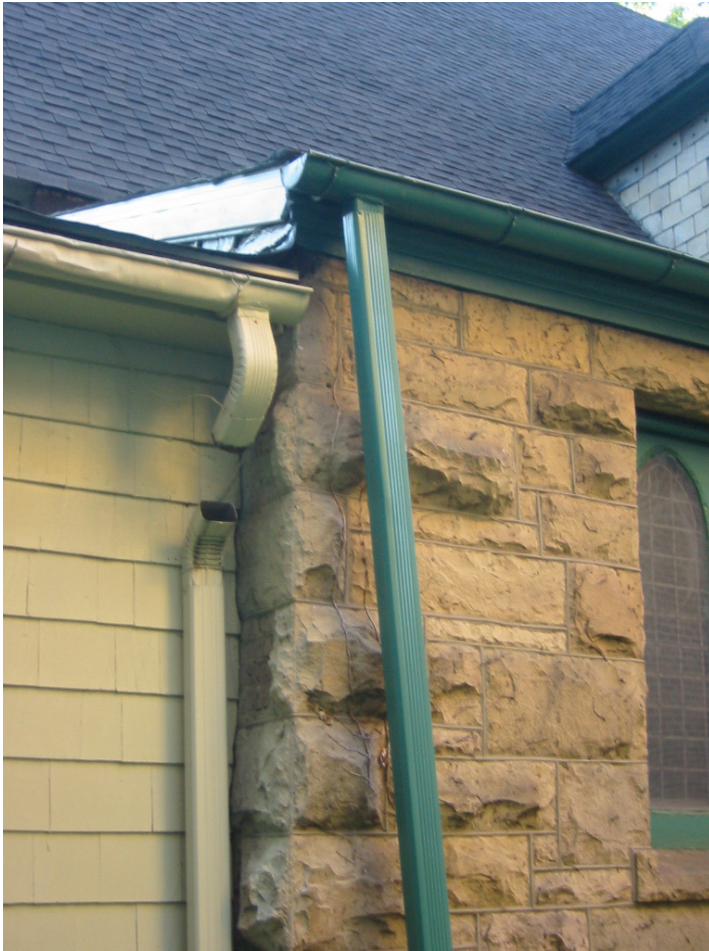
Photograph #41: Lack of maintenance of the gutters and downspouts has caused a large amount of the physical deterioration of building fabric including stone, wood trim, and siding. Several broken and disconnected downspouts could be easily repaired to prevent further problems.

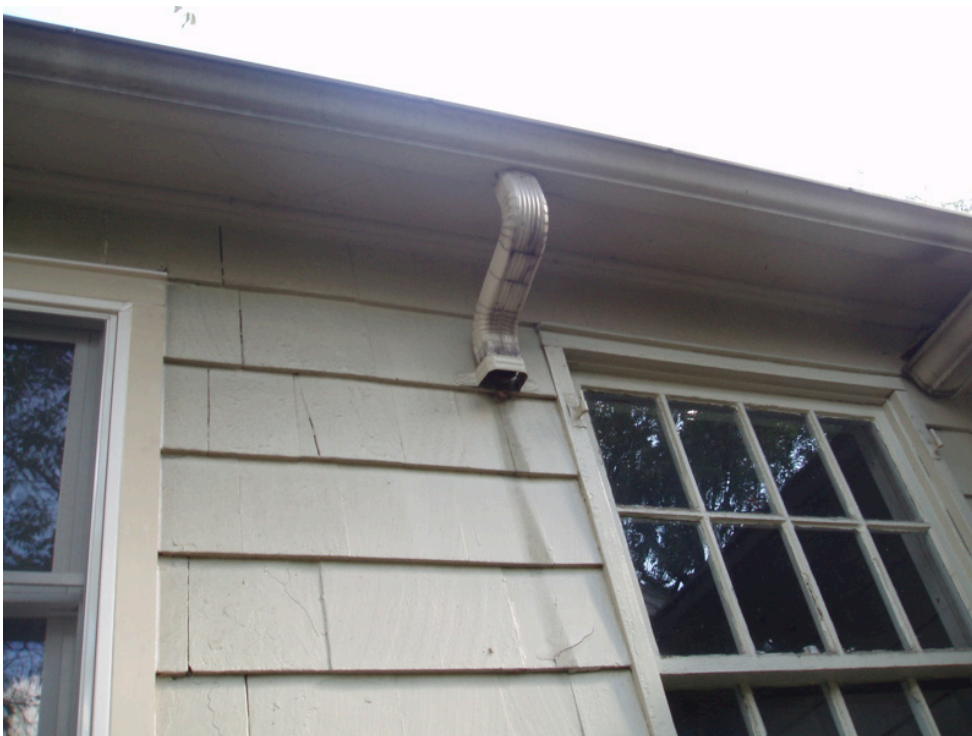
Photograph #42: Missing downspout on the north elevation of the Parish Hall adjacent to a window. This results in paint delamination and wood rot at the window frames.

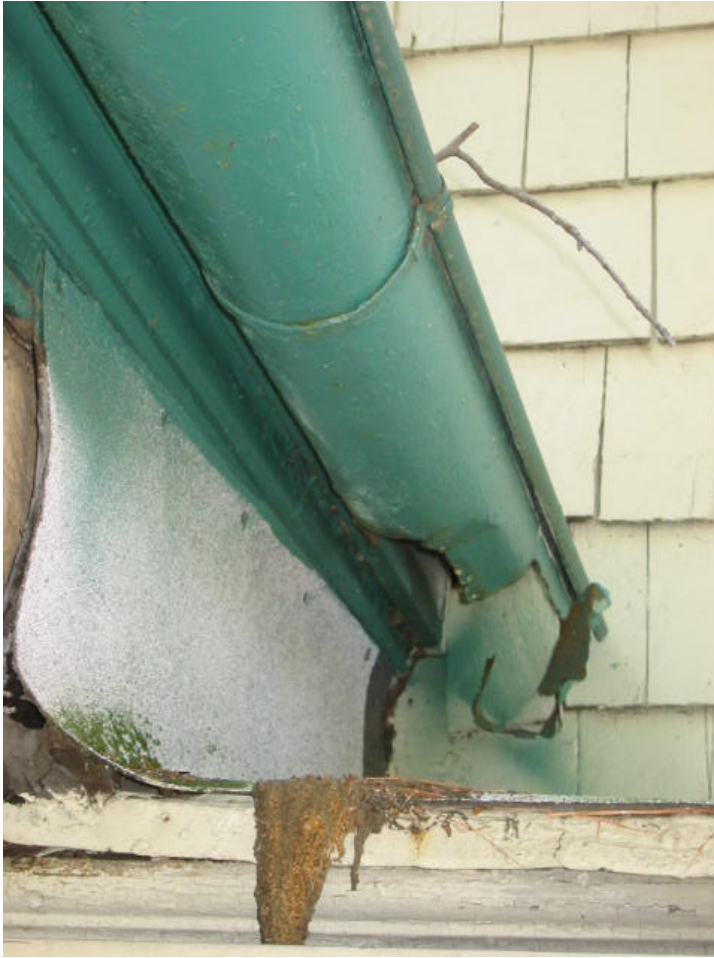
Photograph #43: Church gutter above the East Entry Porch to the Parish Hall. Several inappropriate repairs and deteriorating conditions are shown. The hole in the gutter, which is causing water to seep through the gutter and land on the flat roof over the porch entry. A poor roof patch is folded up the side of the wall, rather than being appropriately completed and flashed to try to prevent water pouring into the building. The gutter that runs along the front of the porch roof is also damaged saturating the masonry below.

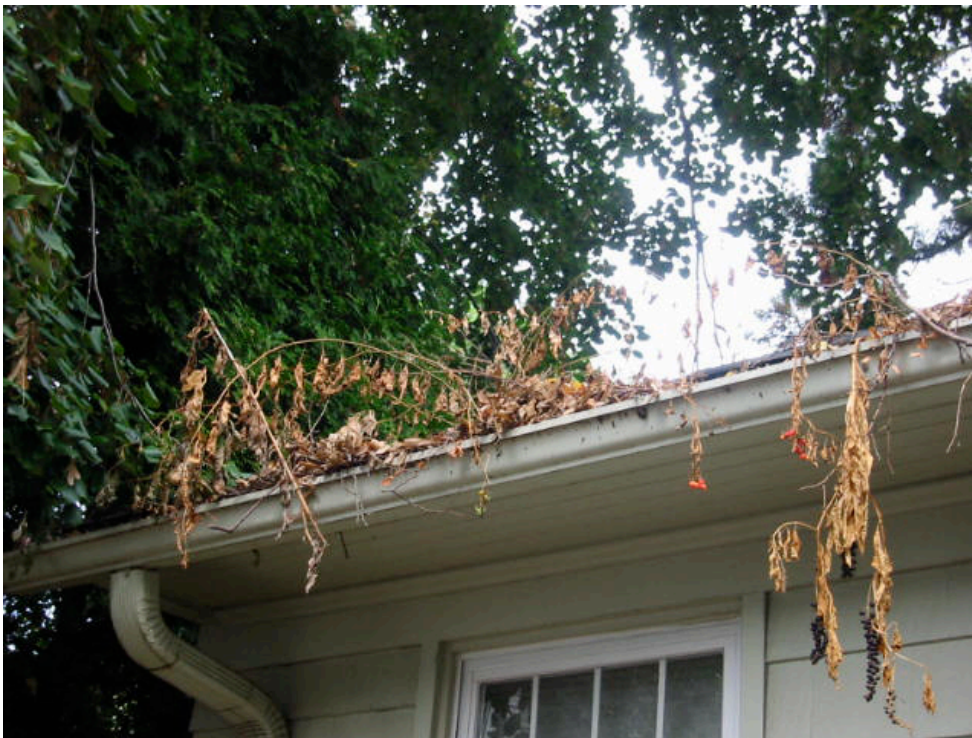
Photograph #44: The gutters on all of the buildings are blocked with plant material and debris from the trees and vegetation surrounding the buildings. Lack of maintenance has caused the gutters and downspouts to become inoperable. Water overflows the roof eaves saturating the ground and footings below. This has been a cause of major flooding in the basement of the Stevens Wing.

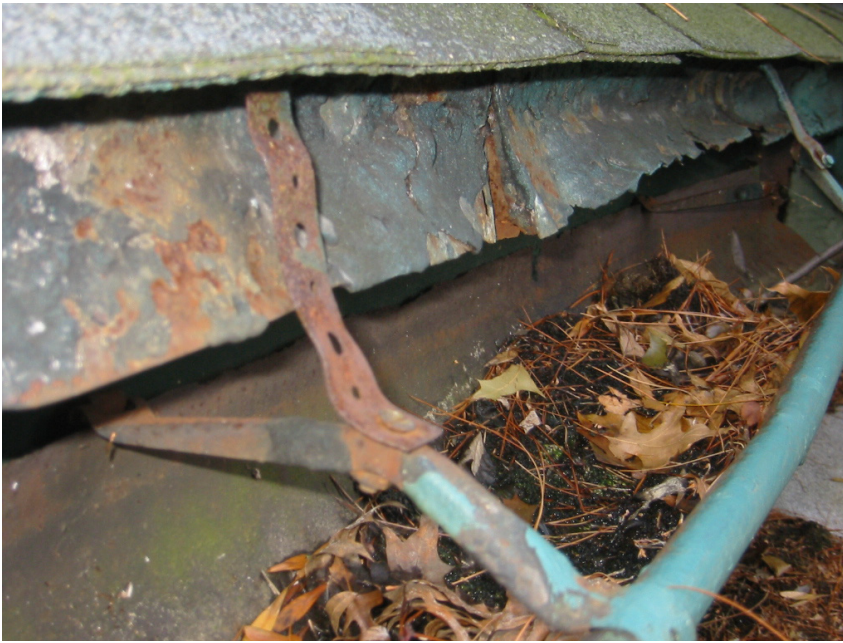
Photograph #45: Detail showing clogged Church roof gutter. Loose and corroded, old gutter straps, as well as corroded metal flashing have contributed to the failure of most of the Church roof gutters.

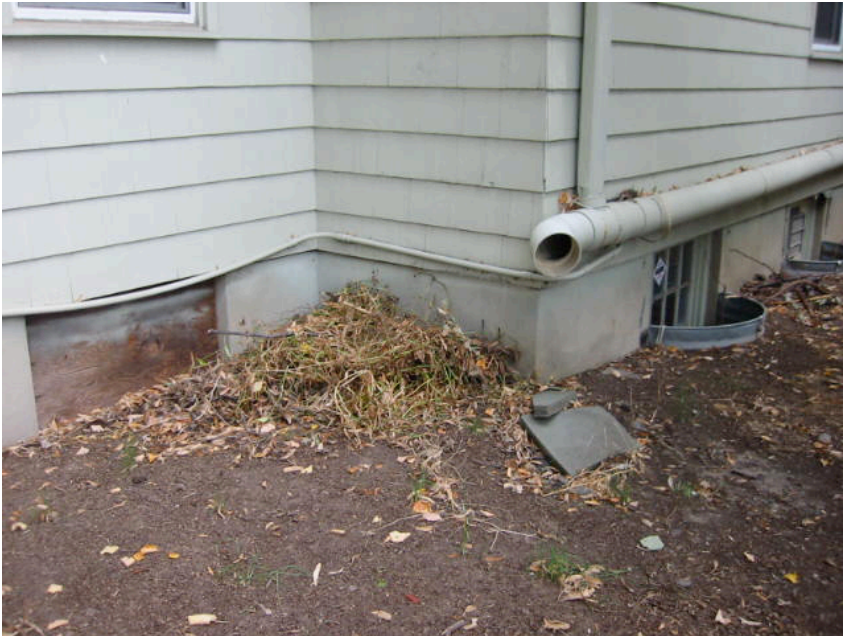
Photograph #46: West elevation of Stevens Wing showing a number of inappropriate repairs. The 7-inch PVC pipe running horizontally along the wall (attached with metal straps) has been installed to prevent water ingress into the basement. However, this does not work if the gutters are blocked. See Photograph #44. This pipe is located approximately 24" above grade and water that collects inside this pipe (when the gutters and downspouts are clean) drains directly onto the ground adjacent to the foundation wall where the water ponds. The debris build up in the corner prevents water from draining away from the building. The basement window on the left has been boarded up with plywood and the soil/debris has built up above the window sill.

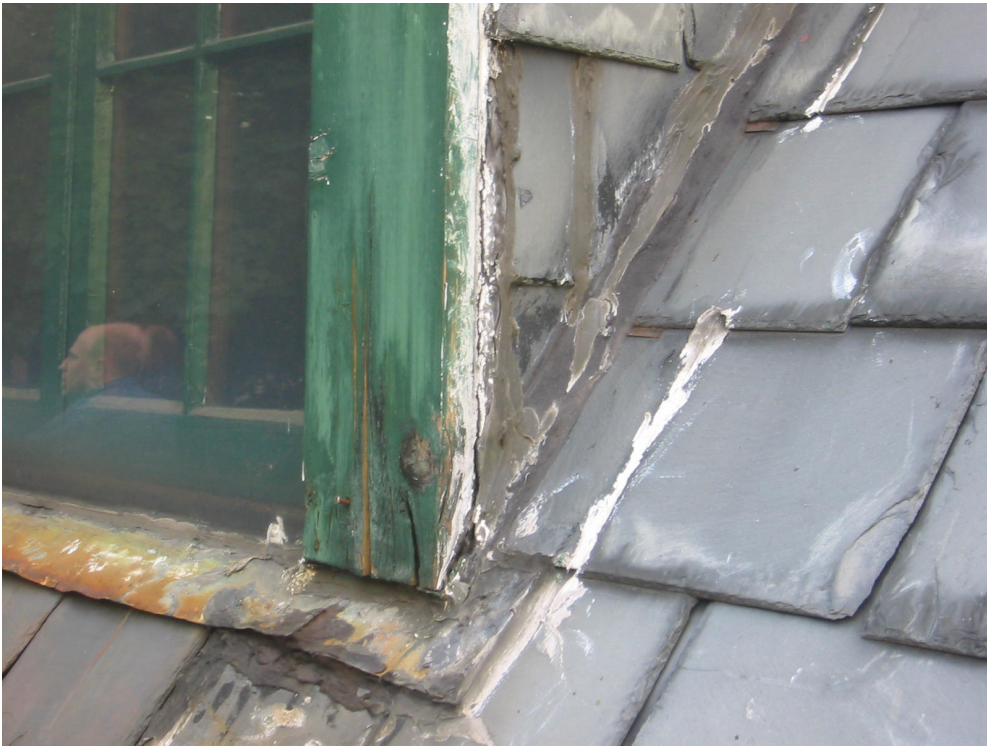
Photograph #47: Detail at south facing Parish Hall shed dormer window. The wood window trim has severe paint loss and ultraviolet damage with wood rot above the base where it meets the roof flashing. The flashing appears to be very old tin or lead, which has aged, cracked and failed. Inappropriate repairs using sealant between slates have unsuccessfully prevented water penetrating at this location.

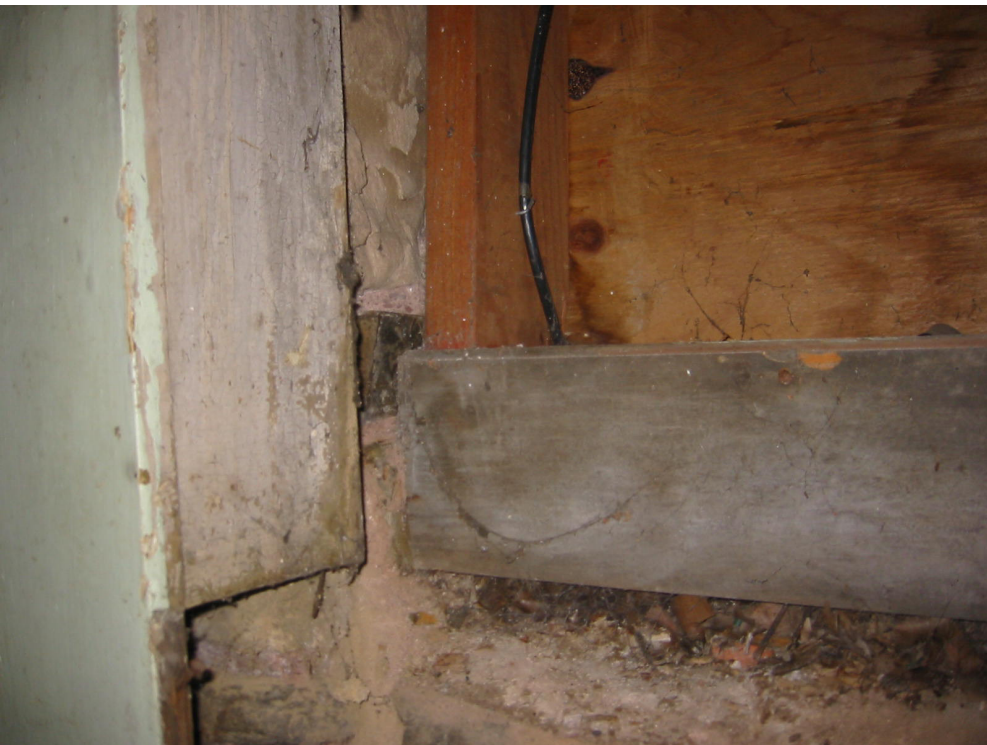
Photograph #48: This detail shows the interior of the basement window beneath the Robinson Window at the East Elevation of the Church. The entire window frame has been removed and plywood installed. There are gaps around the plywood, which are allowing water to enter the basement at this location. Efflorescence and exfoliated stone are prevalent beneath this window.

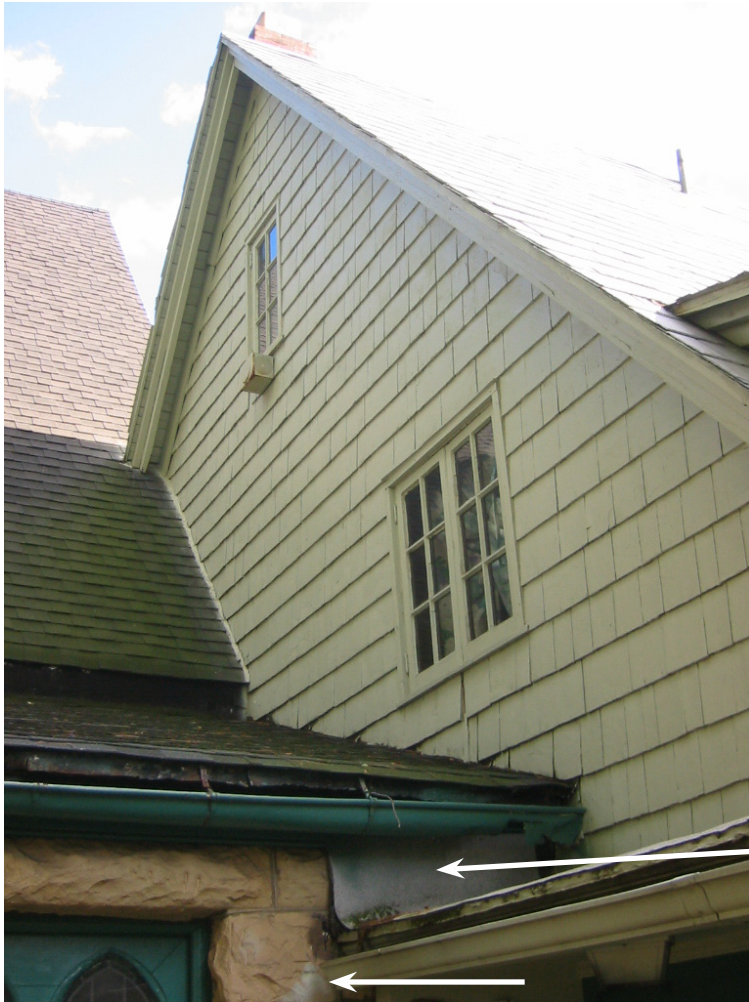
Photograph #49: East Gable of Parish Hall with Porch Entrance roof below. The K-gutter installed on the Porch roof has no end cap and slopes towards the Church allowing water to saturate the North Wall of the Church (see arrows). Two original wood casement windows have not been replaced.

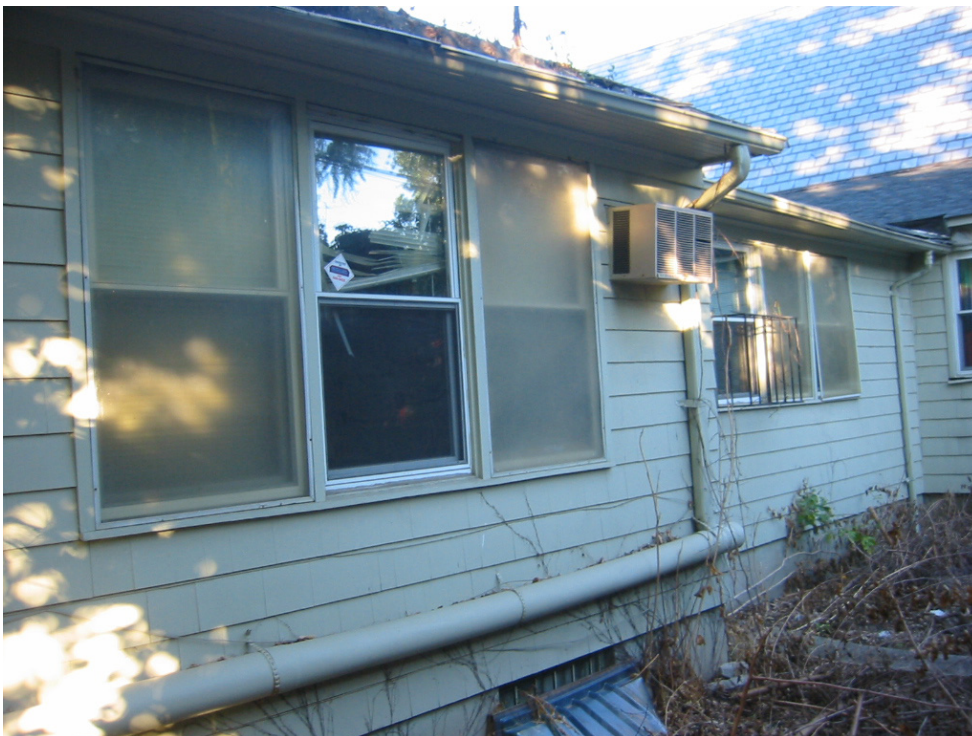
Photograph #50: West elevation of Stevens Wing. A through-wall air conditioner has been installed. Metal window bars have been installed over some windows for security or earlier window mounted air conditioners. The basement windows typically have a plastic corrugated cover, but most of the covers are broken or missing. They do little to prevent water ingress.

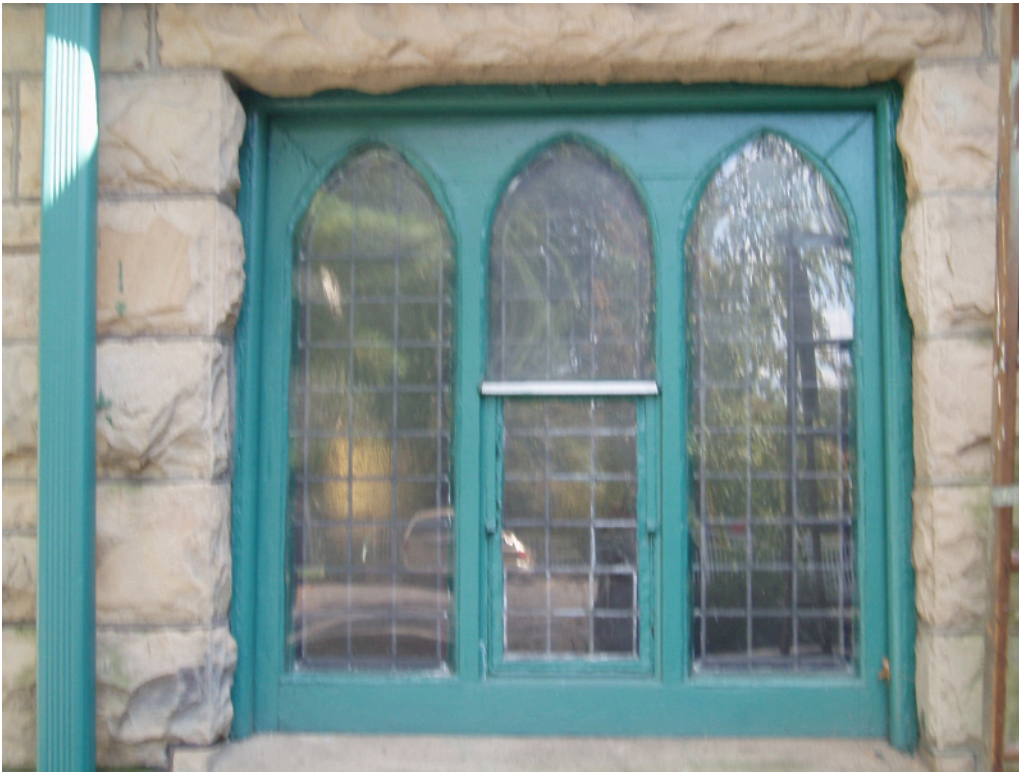
Photograph #51: This is a typical three-bay window at the Church Nave. The wooden window frame has a large wood brick molding which has been inappropriately repaired with sealant. Refer to Femenella & Associates repair on the lead window conditions. (Appendix E)

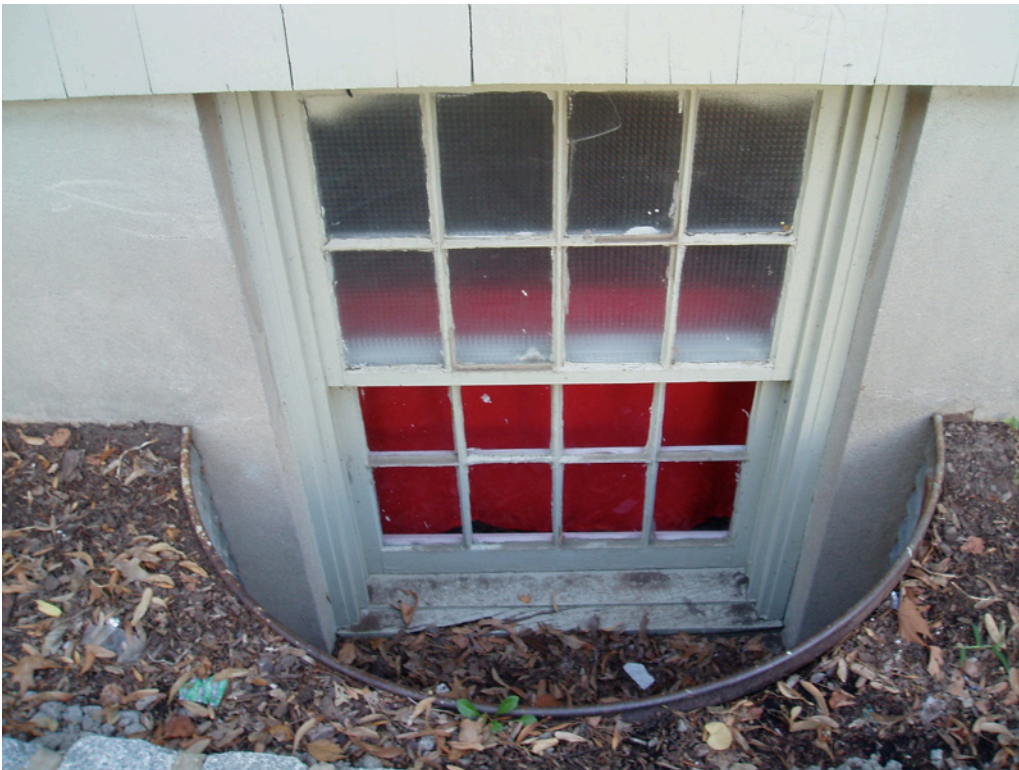
Photograph #52: Typical basement window at the Stevens Wing. The window well drops 18 inches below grade. The window wells are filled with plant debris resulting in rot to many of the sills. Windows are typically 8/8 wooden double hung, they are in fair condition with some paint deterioration.

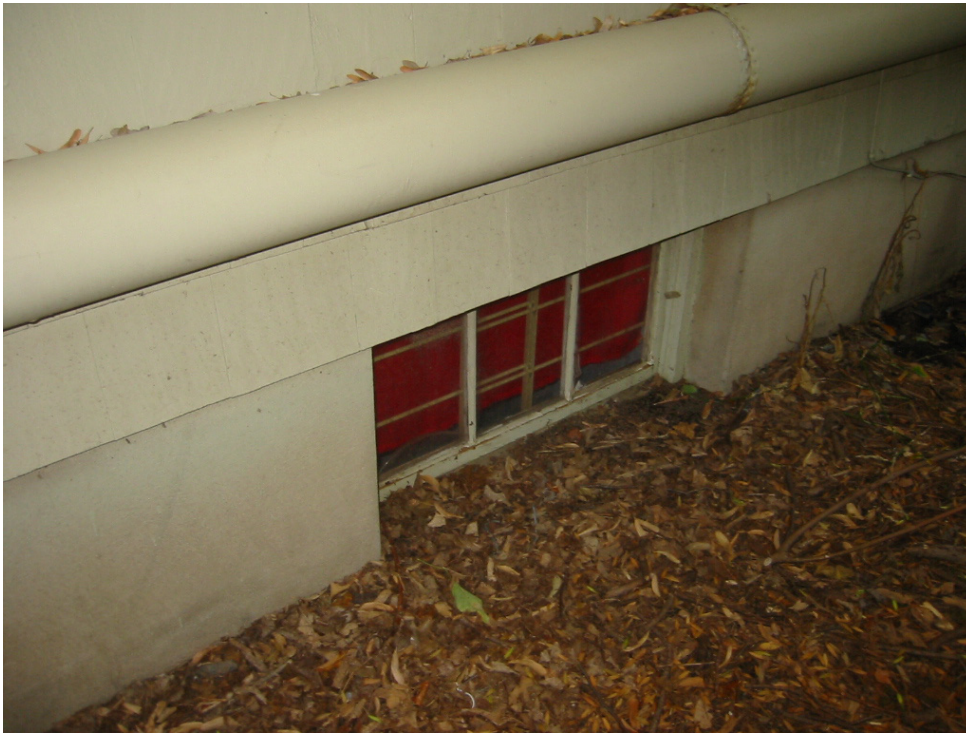
Photograph #53: Basement window on the West Elevation of the Stevens Wing. This window has no window well. Instead, the wooden sill sits directly at grade. This window frame is rotten.

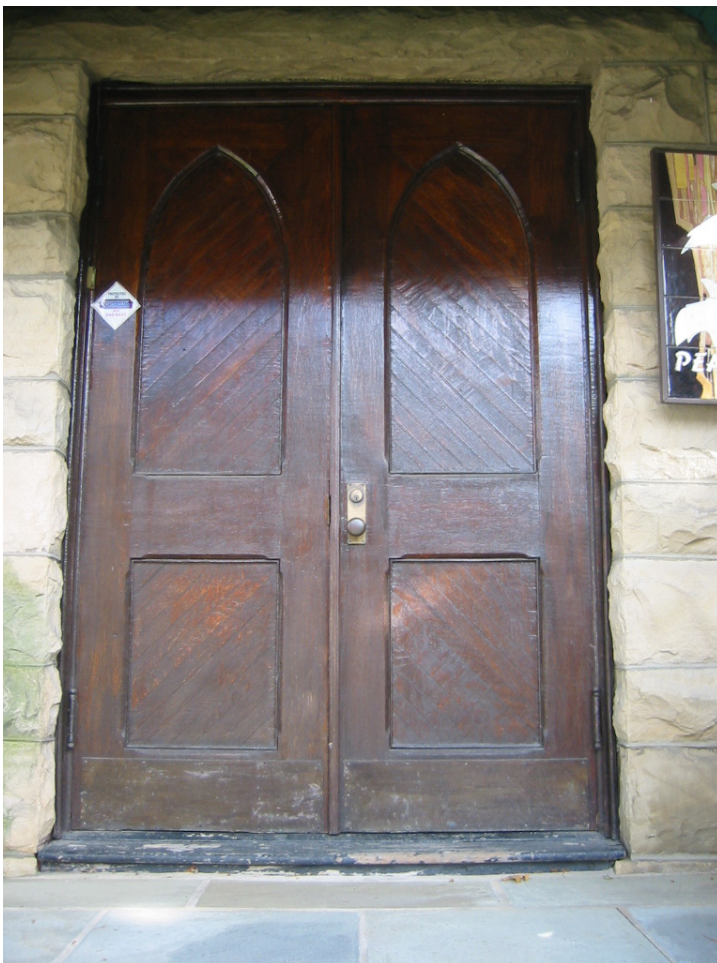
Photograph #54: Wooden doors at North Entrance to the Church. There is some minor UV damage and general wear and tear at the threshold. For paint colors and campaigns, refer to the Paint Analysis. (Appendix B)

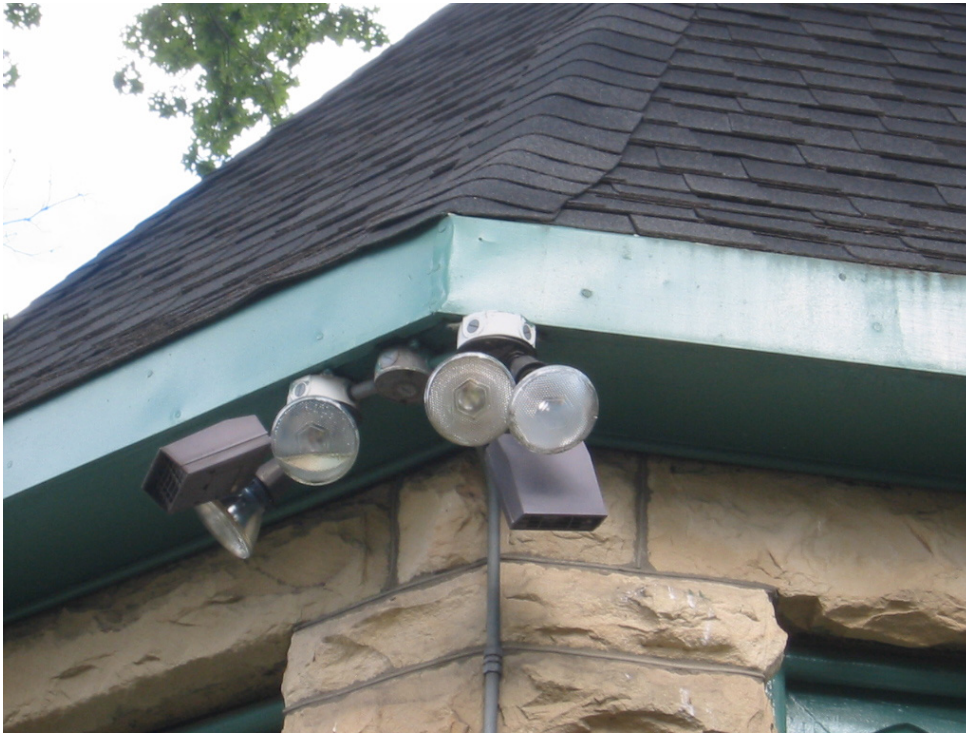
Photograph #55: Security lighting near the Octagonal Room on the North Side of the Church. These lights are contemporary and not in keeping with the historic integrity of the building. Furthermore, the wood cornice has been removed or covered with an inappropriate boxed metal flashing. There appears to be no drip edge between the asphalt shingle roof and eaves.

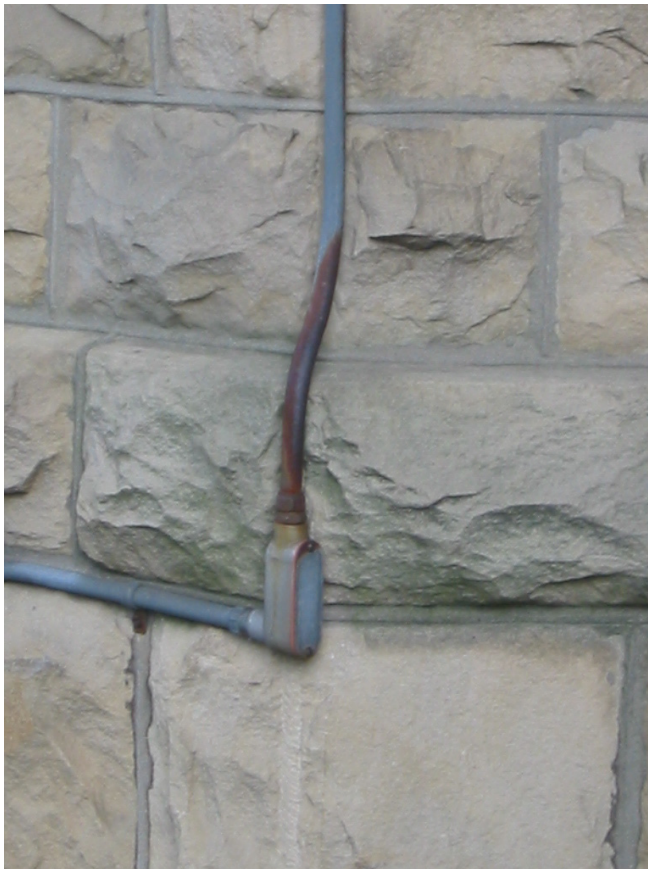
Photograph #56: Utility metal conduits are attached to the exterior surfaces of the building throughout. These attachments are visually inappropriate and can damage the surface material of the building especially if they corrode.
